# ***Dam Integrity Assessment following the Yogyakarta Earthquake, Indonesia***

**Consolidated report on activities undertaken through  
the Monitoring and Information Centre of the  
European Commission & the Joint UNEP/OCHA  
Environment Unit**

**February 2007**

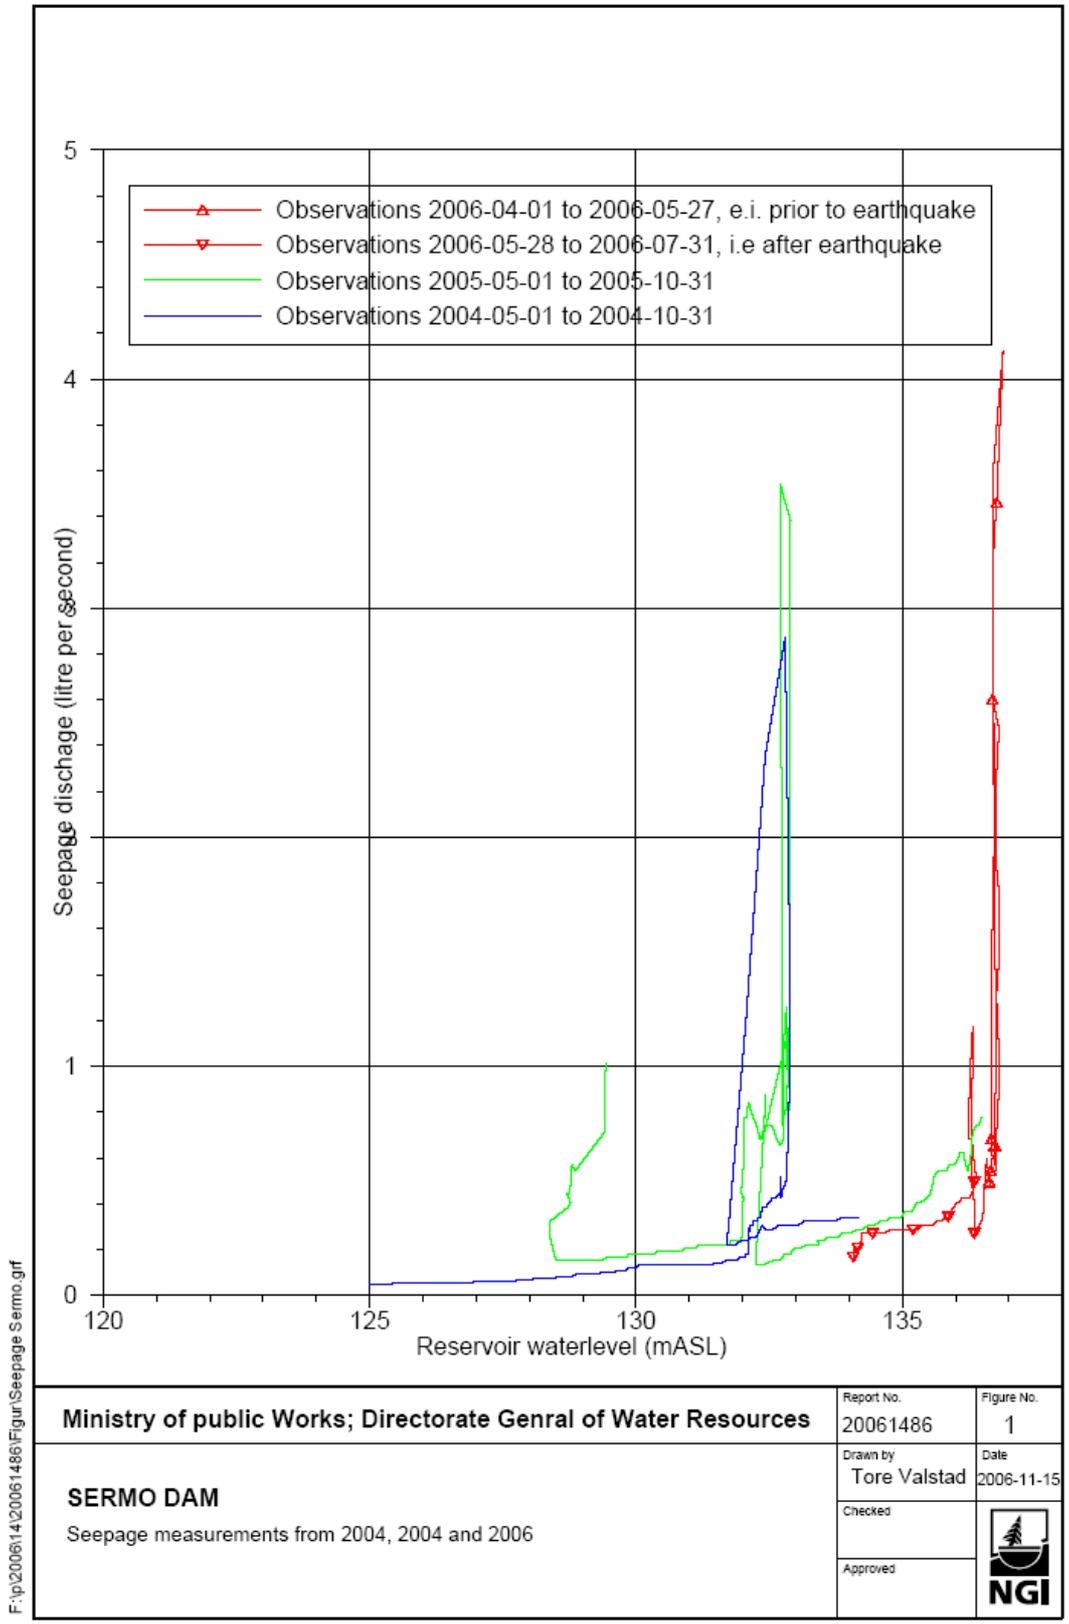
**Figure 1**

<b>Ministry of public Works; Directorate Genral of Water Resources</b>	Report No. 20061486	Figure No. 1
	Drawn by Tore Valstad	Date 2006-11-15
<b>SERMO DAM</b> Seepage measurements from 2004, 2004 and 2006	Checked	
	Approved

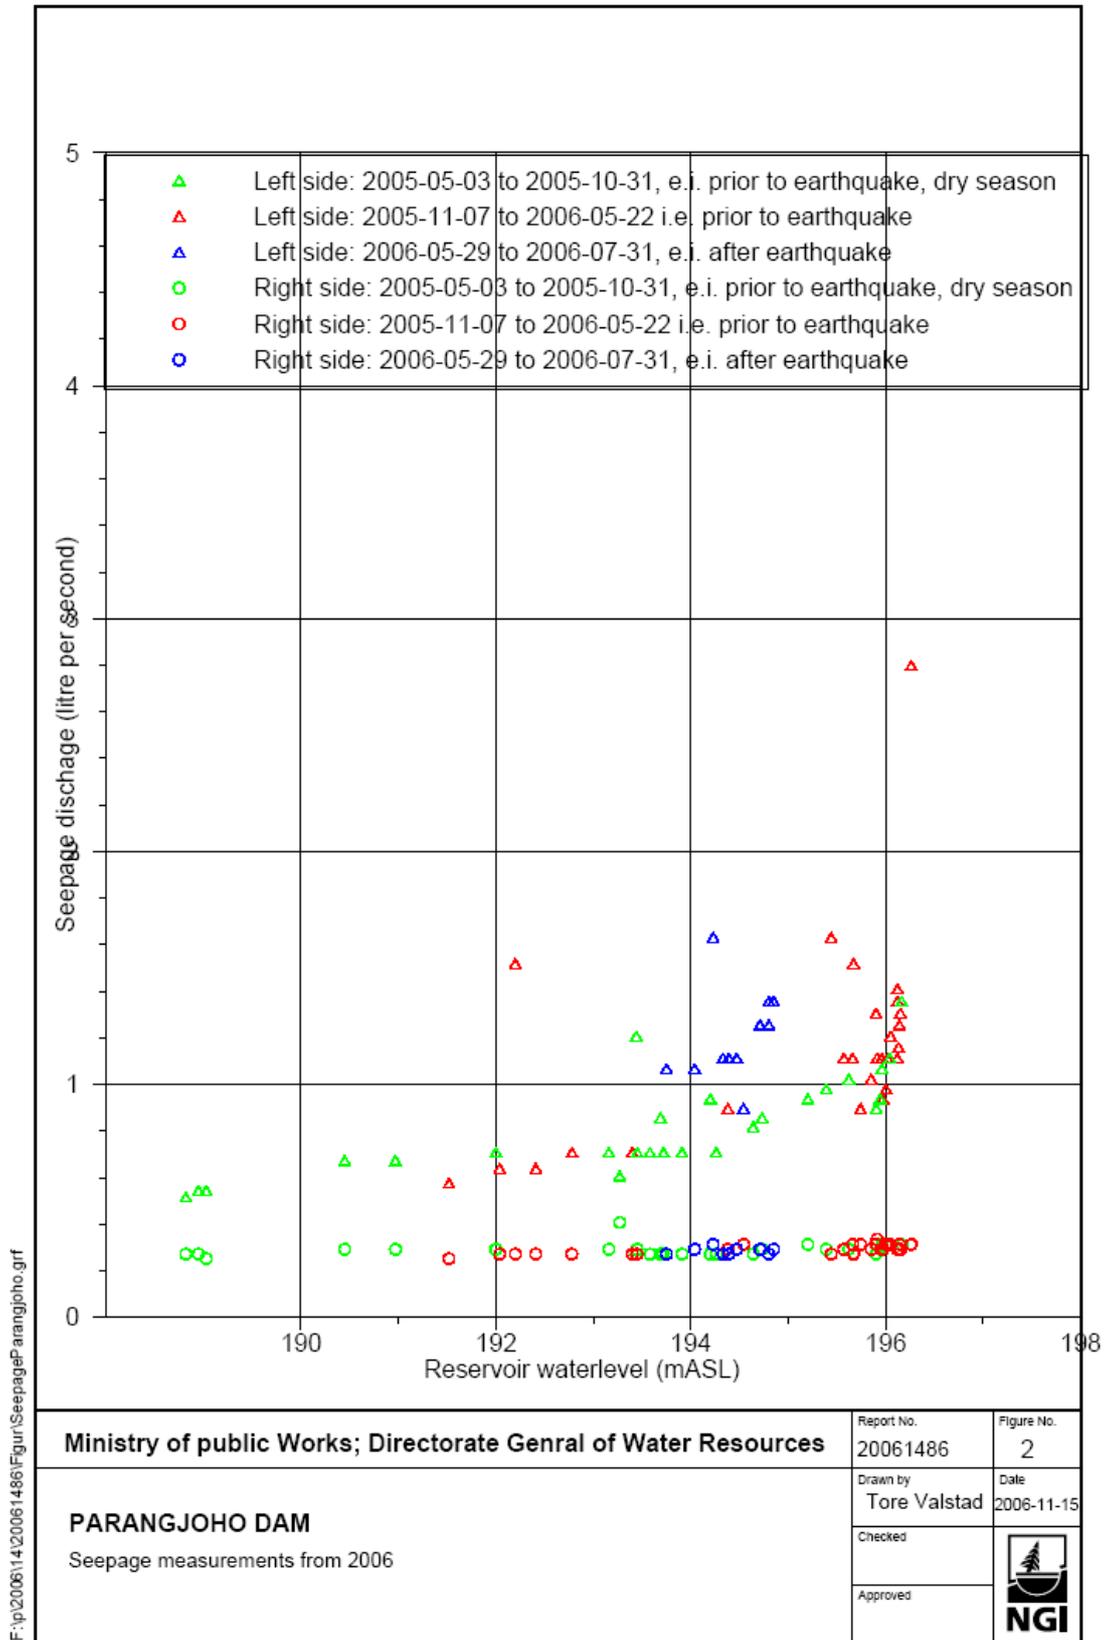
**Figure 2**

There was relatively high seepage value for the low reservoir level and fine sediment in the right drainage section, observed.

The figure for the Parangjoho, Figure 2 (see Annex IV) includes observations from May 2005 to July 2006. The seepage collection and measuring system at Parangjoho is divided in two sections. The left weir measures seepage stemming from the embankment and the right weir measures seepage from springs in the foundation.

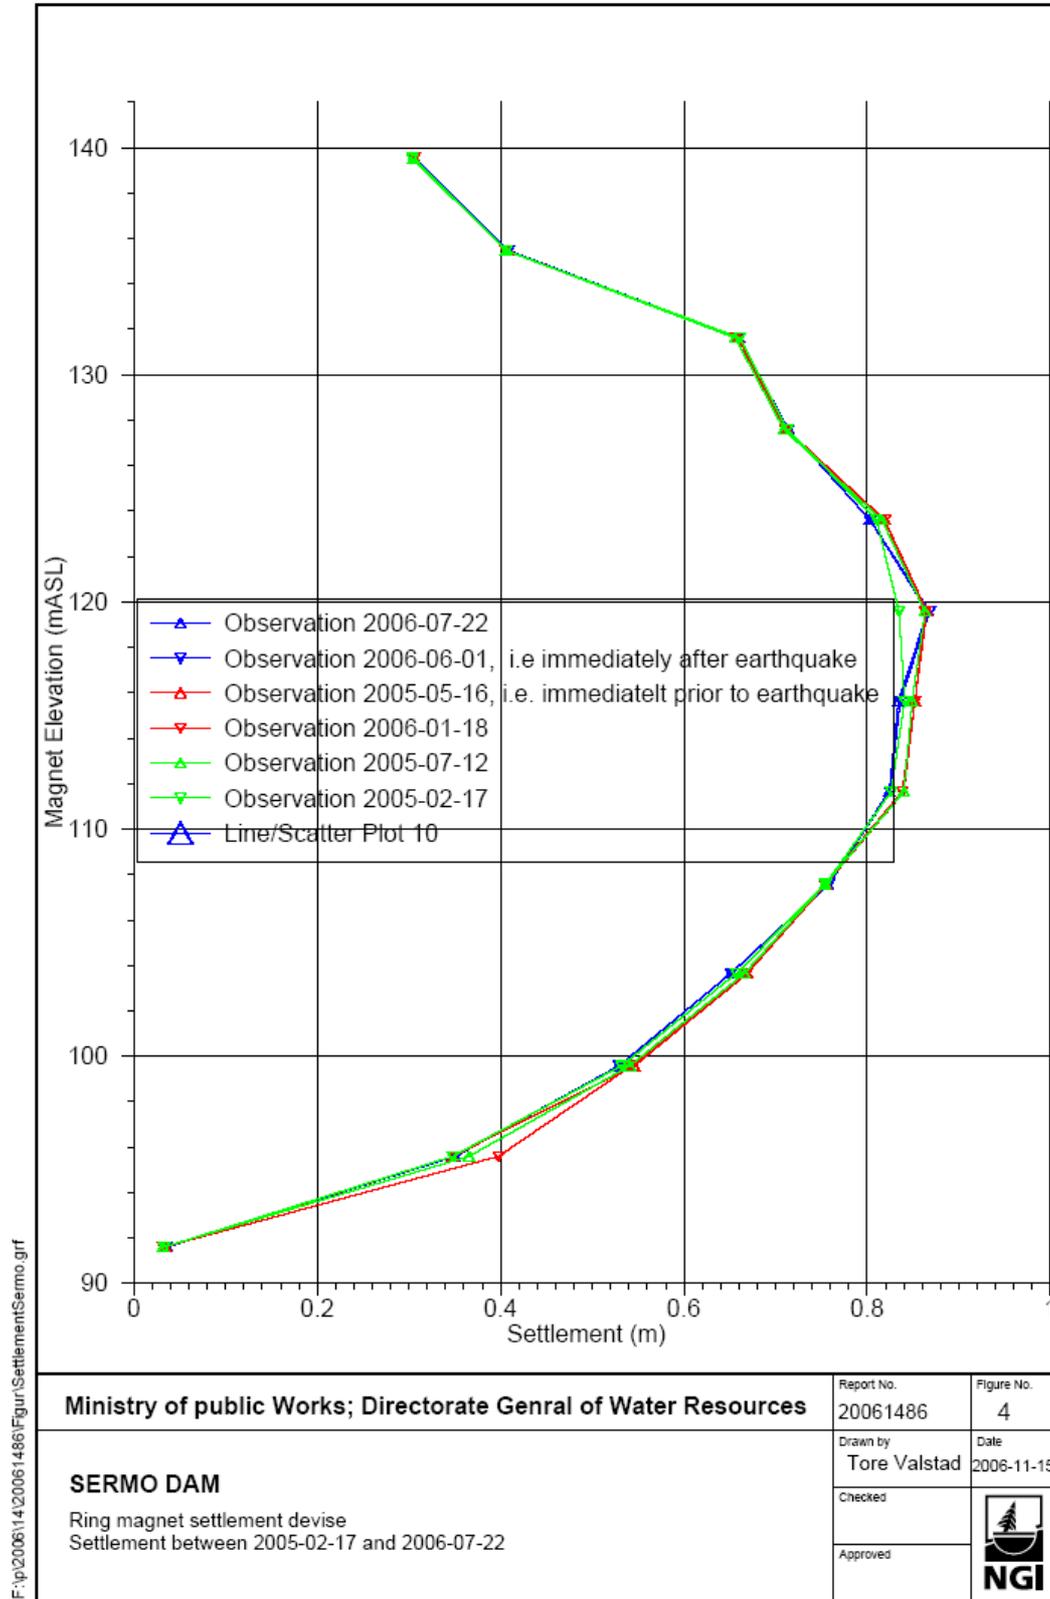
**Figure 4**

The internal settlement device, SG1 shows that some settlement has taken place between elevation 110 and 125 mASL. The plot of the observations between February 2005 and June 2006 in Figure 4 (see Annex IV) show a maximum settlement of 30 mm. Since there is zero settlement above elevation 130 mASL, there must be a zone of compression and extension mid height in the dam and that the top of the dam is arching above this zone. The zone of extension suggests that the material is loosened and that water may percolate easier through this zone during the next filling of the reservoir. Future observations may show recompression of the loosened zone and settlement extending towards the dam surface.

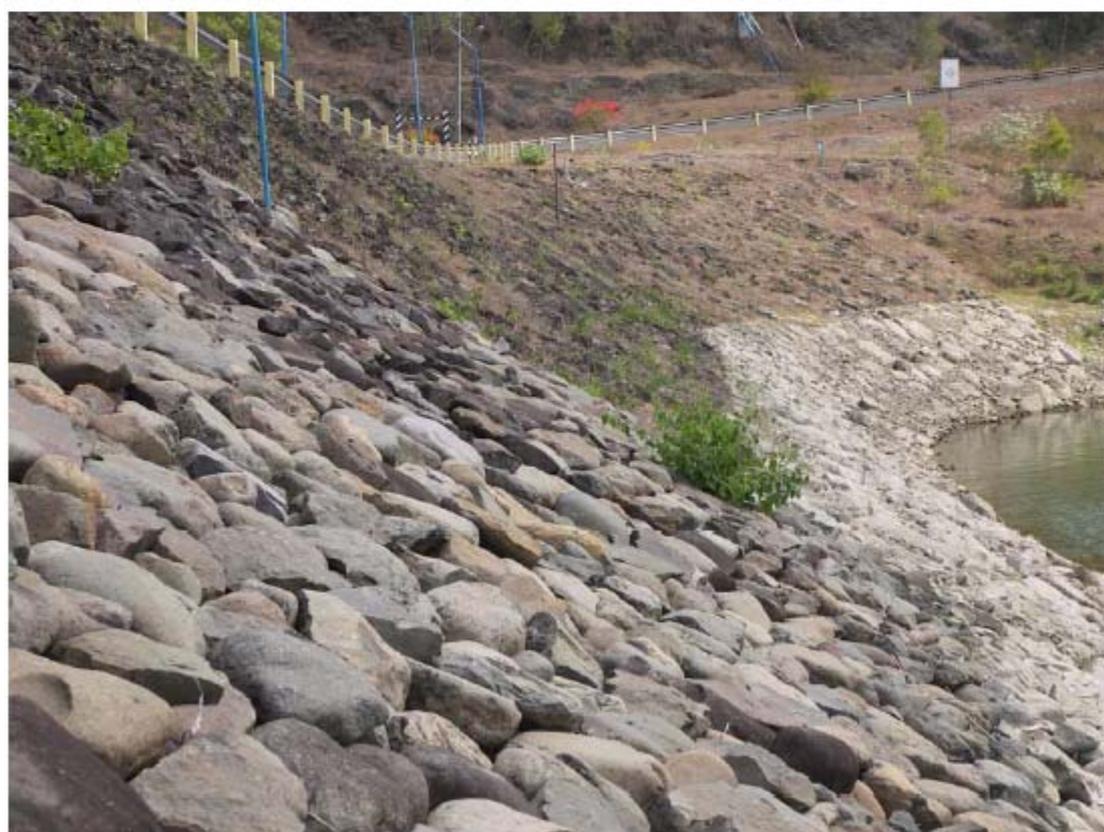
**A2: Sermo Dam; Rehabilitated and original riprap at right abutment**

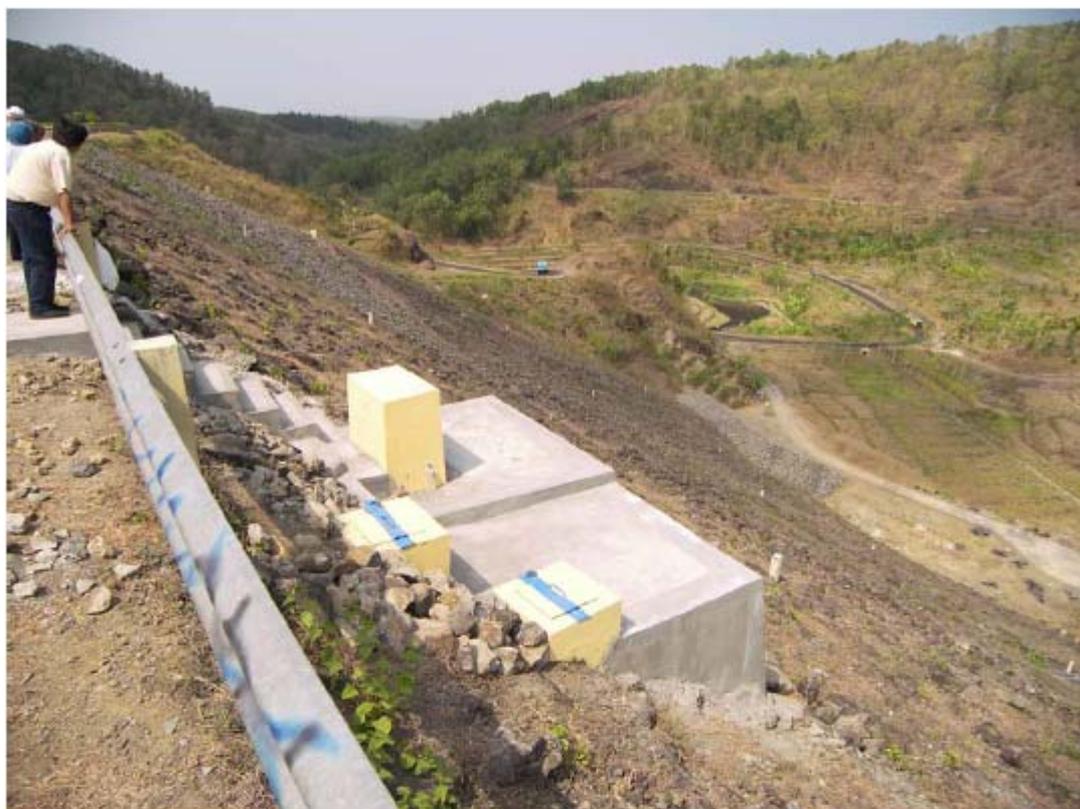
**A5: Sermo Dam; Downstream slope; Instrument installation in the foreground; Buttress fill in the toe at the left abutment**

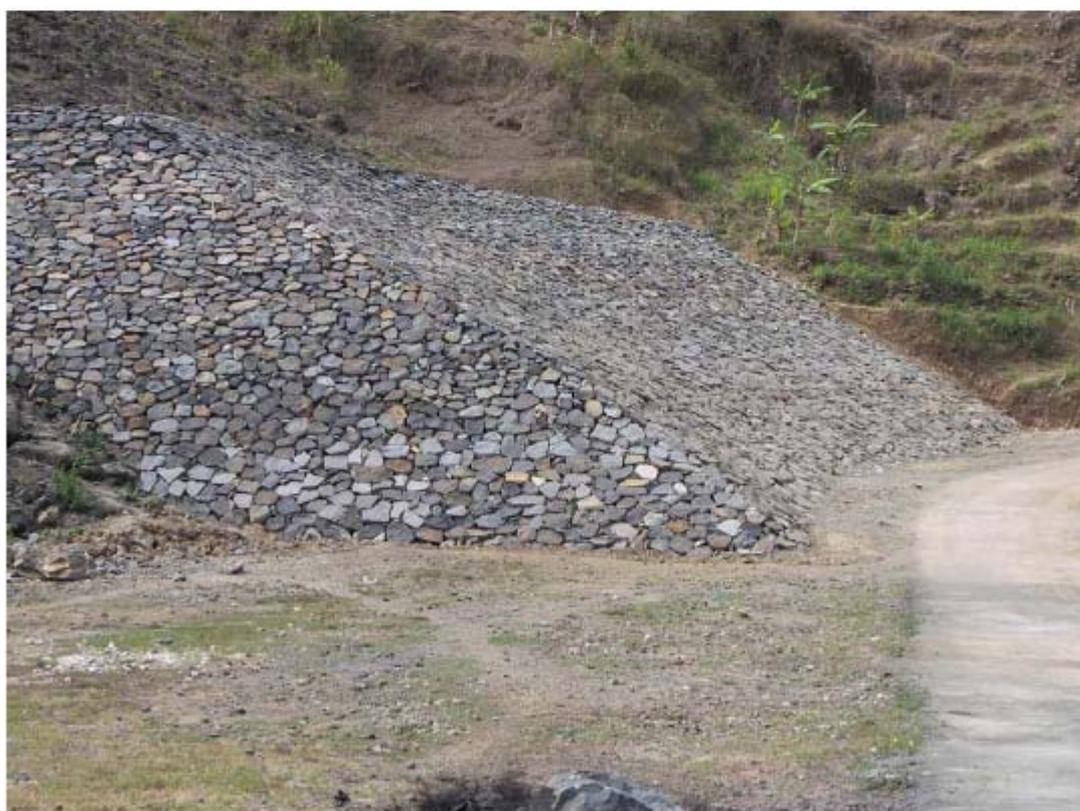
**A6: Sermo Dam; Buttress fill in the toe at the left abutment**

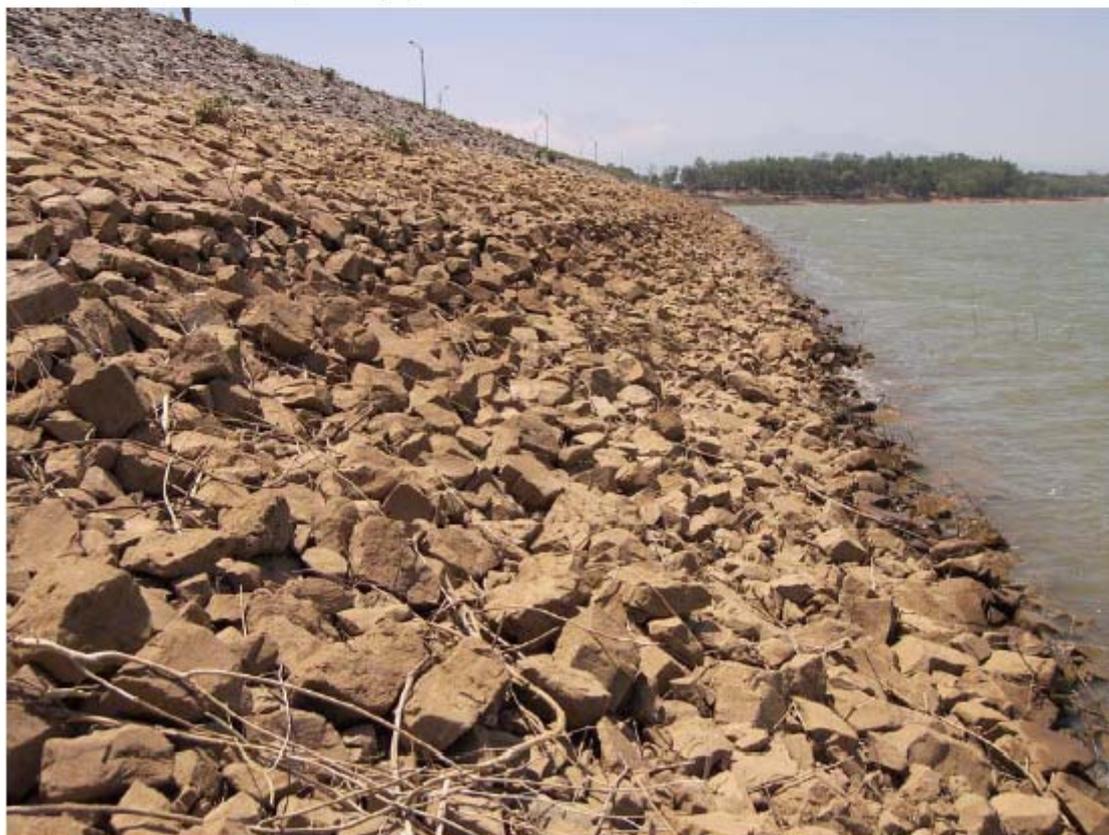
A10: Wonogiri Dam; Upstream slope with wave erosion scars

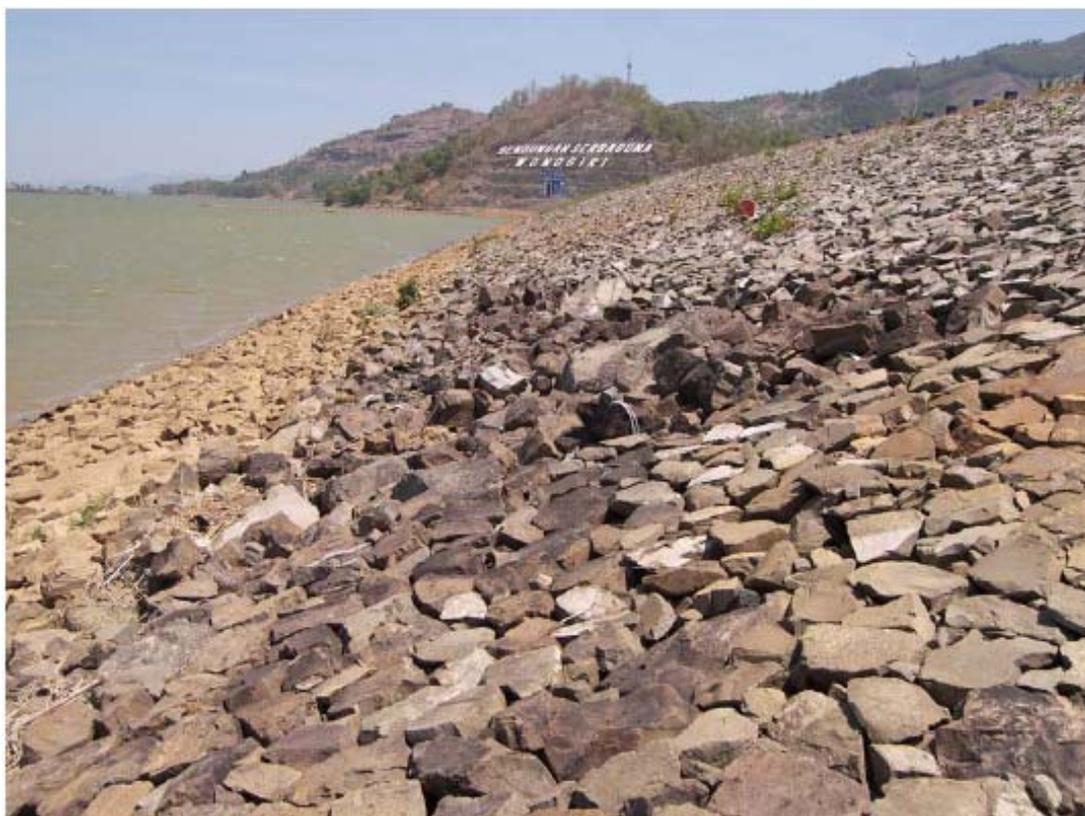
A13: Wonogiri Dam; Upstream slope; Newly rehabilitated riprap possibly displaced during earthquake shaking

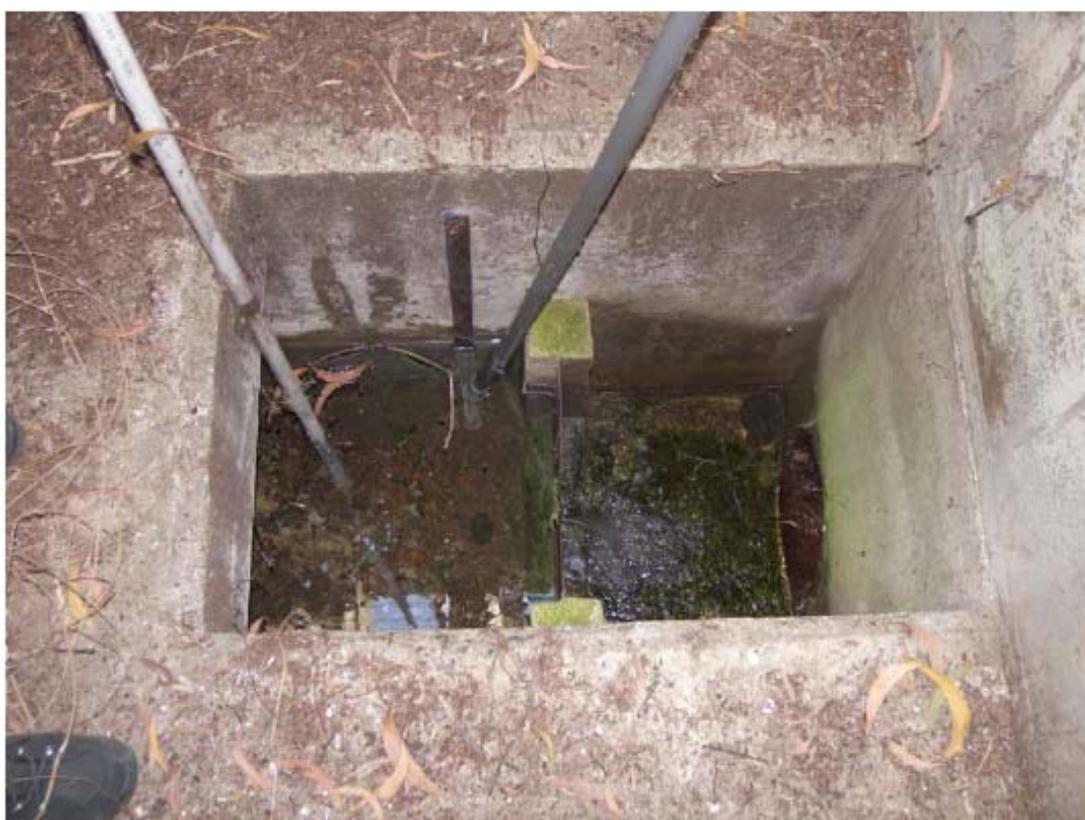
It was observed during the site inspection that the head at the V-notch weir was measured vertically from the V-notch to the water surface. This method is incorrect due to the curvature of the water surface. The head is actually the vertical distance from the V-notch to the upstream water surface unaffected by the weir. The rule of thumb is to measure the head at a location four times the head upstream of the V-notch. This rule of thumb should be implemented at all seepage measuring stations.

A14: Wonogiri Dam; Seepage measurement weir

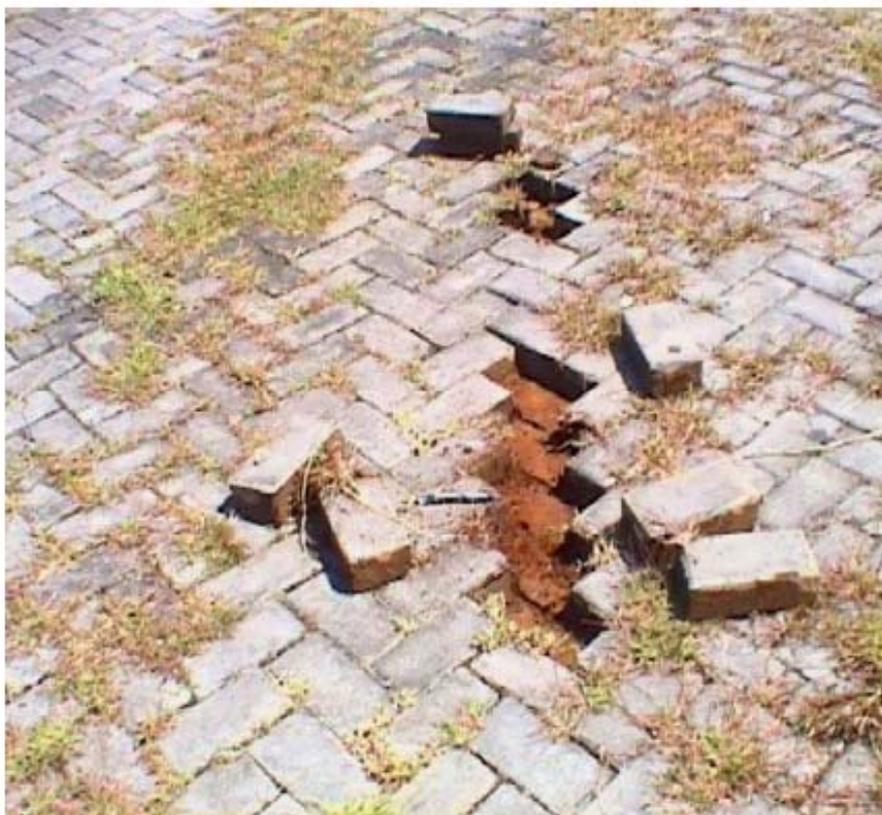
The Parangjoho dam developed longitudinal cracks along the crest during the earthquake. Cracks were evident under the tiles surface on the crest. The maximum crack width is about 20 mm.

Longitudinal cracks are common in embankment dams. They typically occur during first filling of the reservoir and other exceptional loadings. They are, as a rule of negligible consequences to the dam's performance since they do not allow any water percolate through the dam. The standard practice is to backfill the crack and recompact the embankment.

Longitudinal cracks could be a symptom of sliding in the dam body. Sliding would be evident if the two edges of the crack rest at slightly different elevation. This does not seem to be the case for Parangjoho Dam.

**A18: Parangjoho Dam, Crack underneath tiles on dam crest**

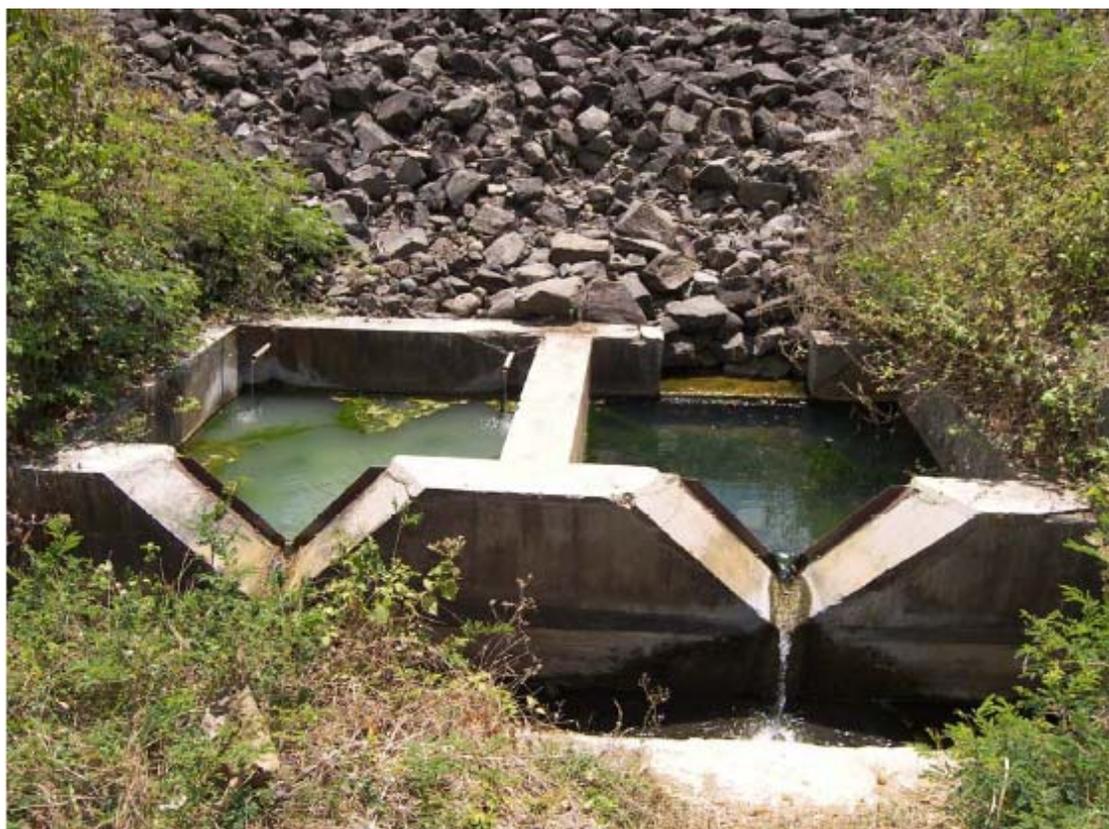
A21: Parangjoho Dam, Dual seepage measurement weir
